## **TECHNICAL BULLETIN** 0048-1200

**REVISION B 02/25/15**

## TECHNICAL BULLETIN: REAR WHEEL CLEARANCE

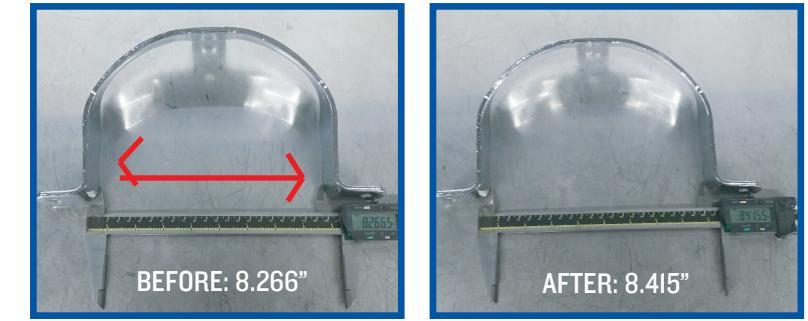
Due to manufacturing variances clearance issues have been occurring on some 2014-2015 Harley Davidson FLH Touring models with HD fender support bracket (p/n 91140-09). In some cases Performance Machine 17" x 6.0", 17" x 6.25", and 18 x 5.5" wheels with 200mm wide Metzeler ME880 tires have been coming very close or making contact with this fender bracket upon installation. Generally installing a PM wheel with a 200mm wide Metzeler ME880 tire results in a centered wheel position with approximately .200" of fender bracket clearance on each side of the tire, however, we have noticed upwards of a .100" difference in the width of the support brackets measured. This technical bulletin outlines a solution that can help center the wheel/tire and create more clearance.

- 2. Remove the side bags to gain access to the fender support bracket
- 3. Remove the two T40 bolts on each side and the I/2" nut under the fender. Remove the fender support bracket.
- 4. With the fender support bracket removed, adjust the fender bracket to approximately 8-3/8" width. (Note: a vice and a large crescent wrench can be used to bend the fender bracket)
